PROJECT OUTLINE AND EXPERIMENTAL TEST

Joint Research Project on "Evaluation and Mitigation of Seismic Risk for Composite Masonry Buildings in Bhutan"

in the framework of SATREPS (Science and Technology Research Partnership for Sustainable Development) 2017-2023

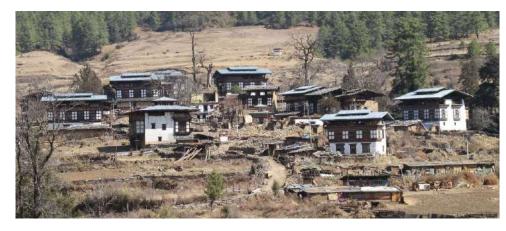
1. Rammed earth construction

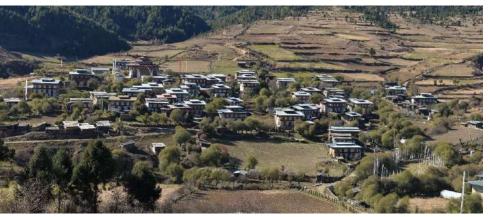
2. Random Stone Masonry Construction

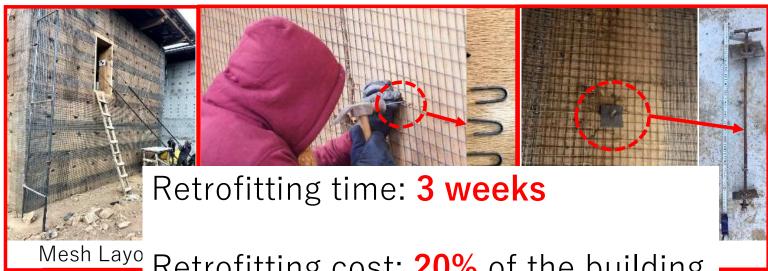
Retrofitting method rammed earth

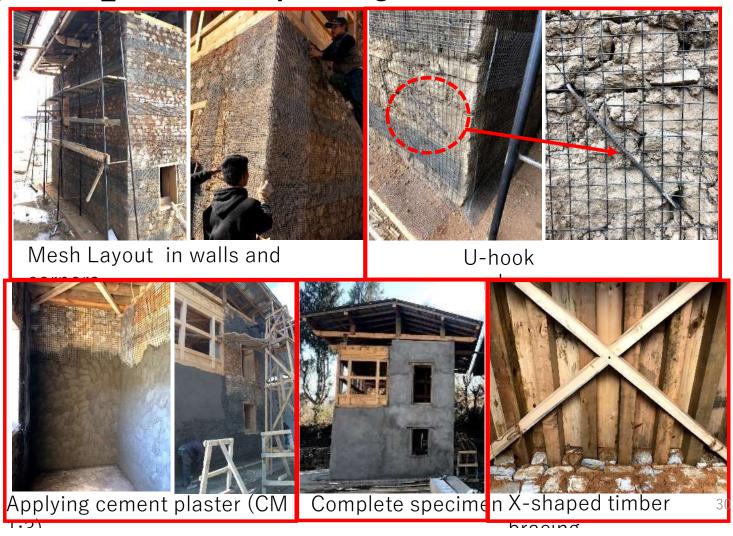
Retrofitting method_stone masonry building

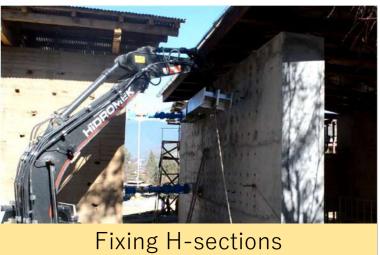
SET UP AND INSTRMENTATION

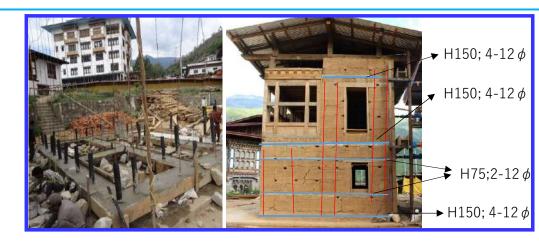
Rammed Earth: Full-scale test

Unreinforced

- Mesh (12G+16G)
- CM 1:3

- RC $(80 \, \phi \, ;$ post 12ϕ)
- RC band

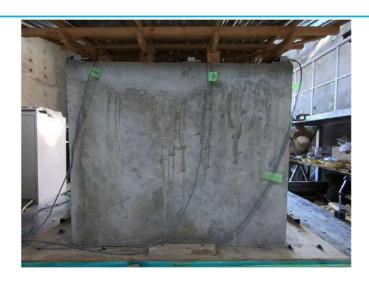
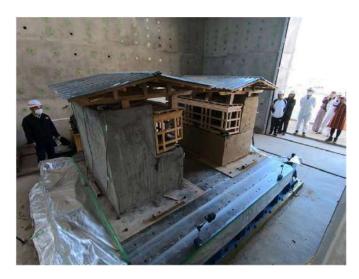
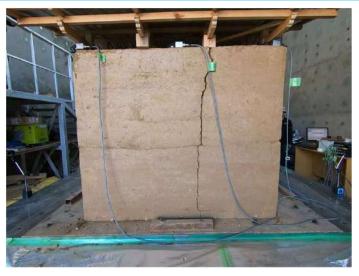
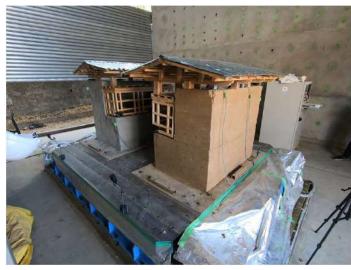
SHAKING TABLE TEST_RAMMED EARTH
