# **Manual for Seismic Resilient Construction and Retrofitting of Rammed earth and Stone masonry Houses**

## **Experimental results and data**

Project on Evaluation and Mitigation of Seismic Risk for Composite Masonry Buildings in Bhutan  
in the framework of SATREPS Project

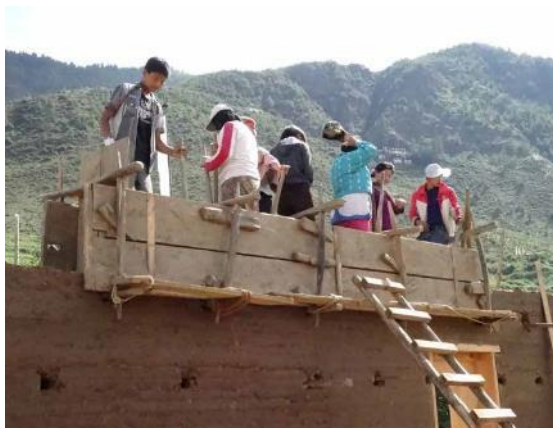
Figure 1-3. Ramming of Rammed Earth Structure Figure 1-4. Traditional Rammed Earth Buildings

The traditional architectural construction of Bhutan follows different construction practices across the country's geography. The western region has traditional rammed earth construction, and the eastern region has mostly stone masonry structures. The traditional rammed earth construction includes a foundation made of stone block masonry, above which the rammed earth walls are constructed. The normal rammed earth private house building is usually two to three stories high, where the first floor is used as a space for live stocks or warehouses. This floor is usually a closed space with very few openings. The second and third floors are living spaces with walls, floors and inner pillars/posts made of wood or mud. The timber roofing at roof rests on the wooden horizontal beams on top of the walls. Traditional constructions usually have roofs with long plate rocks. The construction materials of rammed earth walls involve red clay/soil with small pebbles, locally available in the nearby area of the construction site. The soil is carried in bags to the construction site and poured inside the space within the wooden formwork, followed by ramming of the soil until the upper soil layer becomes smooth, polished and sufficiently hard (Figure 1-3). After the ramming of one-layer, new soil is poured over, followed by ramming. A similar procedure is repeated for about 7-8 layers. After one block is completed, the wooden formwork is removed and installed at the next construction place.

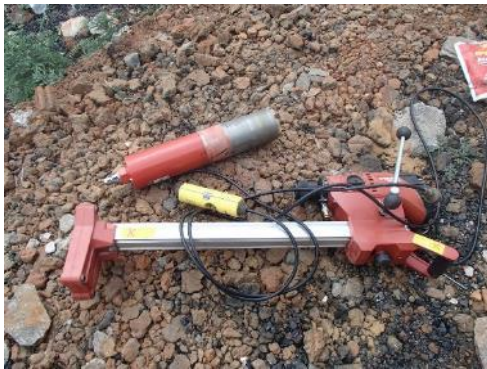
Figure 2-1. Core drill

For structural calculation of new rammed earth structures and seismic evaluation of existing rammed earth structures, material properties such as compressive strength, tensile and shear strength, and Young's modulus of rammed earth should be obtained. In order to grasp mechanical characteristics of rammed earth and to clarify the effectiveness of use of lime for rammed earth, compressive strength testing on two types of rammed earth test samples were conducted: one type from the actual structures and the others collected from rammed earth blocks prepared on the site [1]. It is difficult to cut rectangular form of rammed earth sample. Therefore, by using a core drill with a diameter on 100mm (DD120 Hilti Corporation) shown in Figure 2-1, coring of the sample about 100-200mm long was conducted (Figure 2-2).

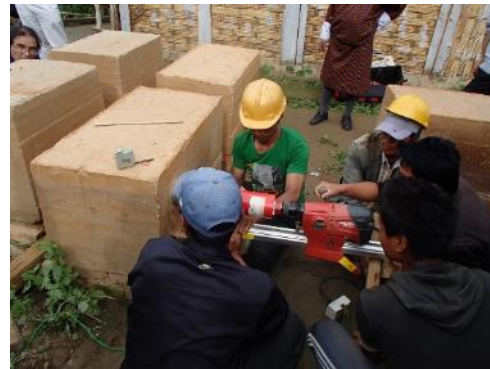
Figure 2-2. Sample Coring

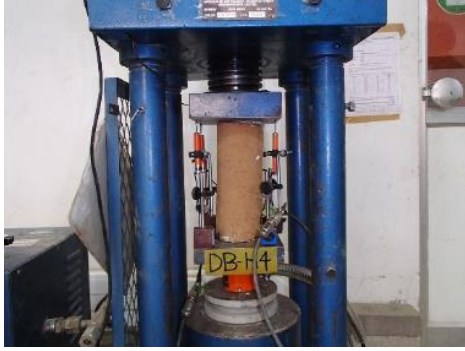
Figure 2-3. Compressive strength testing

Each test sample was judged if it was suitable for being used for compressive strength testing (Figure 2-3) or for tensile strength testing (Figure 2-4) according to its length and surface crack. In the case of compressing strength testing, test pieces that have approximately twice the length of their diameters. Test samples were irregularly shaped because of processing difficulties; therefore, samples were collected so as to ensure that both top and bottom surfaces were compressed flat and capped with plaster.

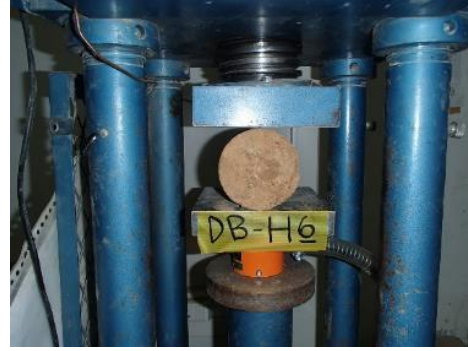
Figure 2-4. Tensile strength testing

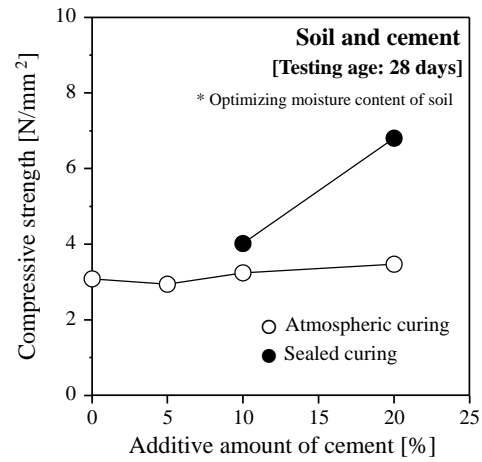
Figure 2-14. Relationship between compressive strength of rammed earth and additive amount of cement

On the other hand, in the case of sealed curing, the strength increased due to the hydration of cement, and as shown in Figure 2-14, the strength increased with the addition of cement. These results indicate that the addition of cement is not effective on the surface layer of rammed earth, but it can be expected to be effective in increasing the strength of the slowly drying interior.

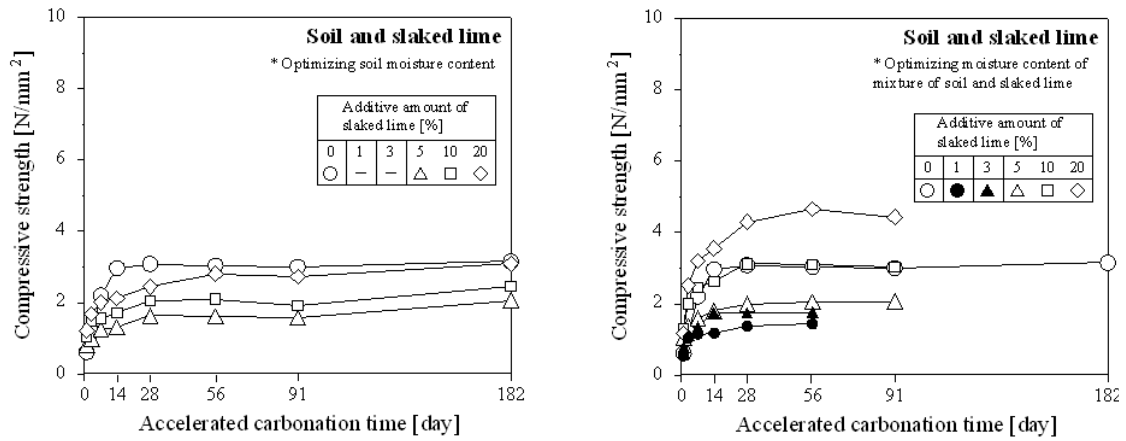
Figure 2-15 shows the relationship between carbonation age and compressive strength of specimens to which slaked lime was added. It was found that the addition of slaked lime is not effective as a strength improvement measure, because the increase in strength is small even when the amount added is 20%.

Figure 2-15. Relationship between compressive strength and accelerated carbonation time

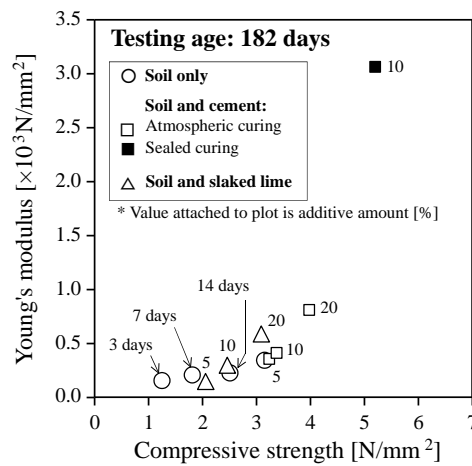
Figure 2-16 shows the relationship between compressive strength and static elastic modulus. The static modulus of elasticity was found to be one to two orders of magnitude lower than that of concrete of general strength level. It was  $0.34 \times 10^3 \text{ N/mm}^2$  for the 182-day-old soil specimen, and  $3.1 \times 10^3 \text{ N/mm}^2$  for the 10% cement sealed specimen. Similar to concrete, it was confirmed in this test specimen that the static elastic modulus increases as the compressive strength increases.

Figure 2-16. Relationship between Young's modulus and compressive strength

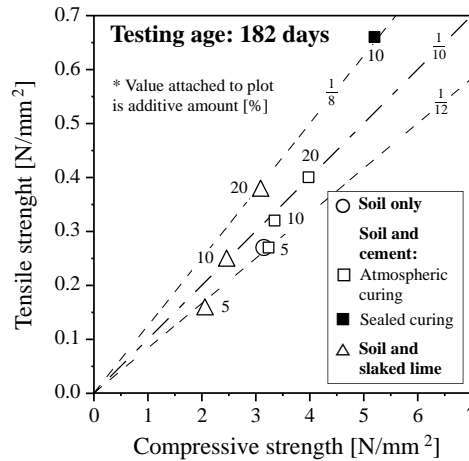
Figure 2-17 shows the relationship between compressive strength and tensile strength. The tensile strength of the specimens was 1/12 to 1/9 of the compressive strength, which is the same as that of ordinary concrete.

Figure 2-17. Relationship between tensile strength and compressive strength

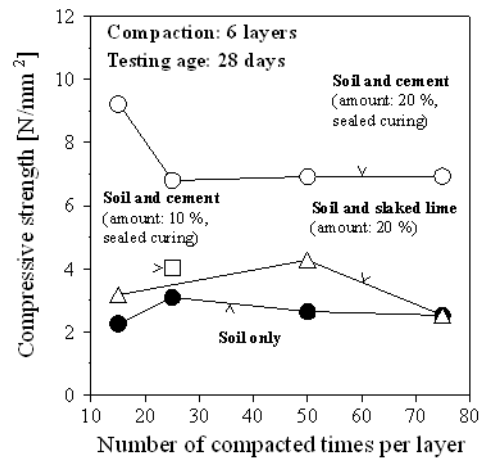
Figure 2-19 shows the relationship between the number of compactions and the compressive strength. The compressive strength also has a maximum value with respect to the number of times of tamping, and in the range of the experiment, the maximum value was 1.4 times that at 25 times compared to 15 times. The compressive strength of the cement-added sealed specimens increased as the number of tamped layers increased. The relationship between the number of times of tamping and the compressive strength of the cement-added sealed test specimens was large at 15 times, but remained constant at 25 times or more.

Figure 2-19. Relationship between compressive strength and number of compacted times per layer

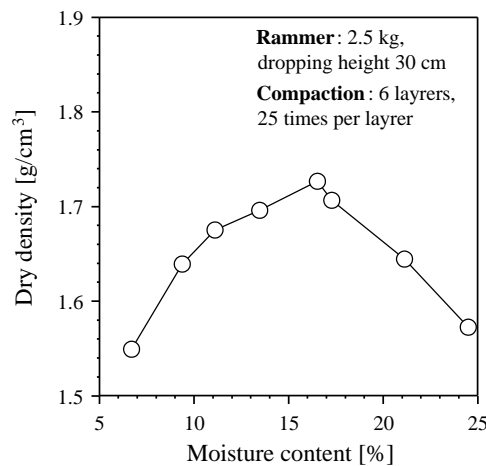
According to Figure 2-20, in the material used, the hydration rate at which the dry density was approximately maximum was about 15%.

Figure 2-20. Relationship between dry density of rammed earth and moisture content of soil

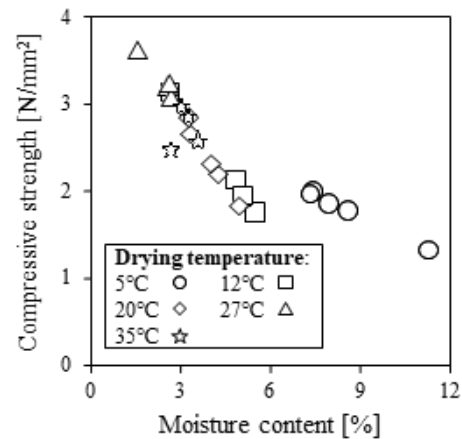
Figure 2-24 shows the relationship between water content and compressive strength. It can be seen that there is a good correlation between the water content and compressive strength regardless of the drying temperature.

Figure 2-24. Relationship between compressive strength and moisture content

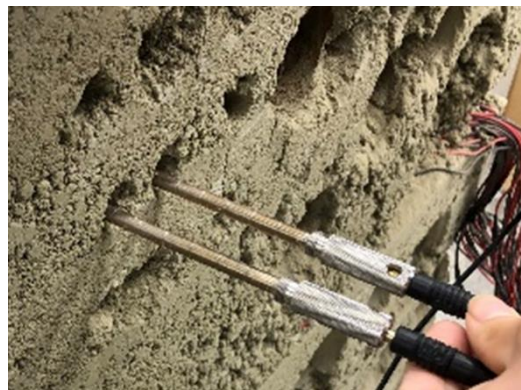
Figure 2-26. The inserted electrodes

First, drill 10 mm diameter holes parallel to the rammed earth with a center-to-center distance of 5 cm. As shown in Figure 2-26 and Figure 2-27, electrodes with diameter of 10 mm were inserted, and the electrical characteristics of the electrode were measured using HI-800 (Figure 2-28) commercially available in Japan. The count value is inversely proportional to the electrical resistance between the electrodes.

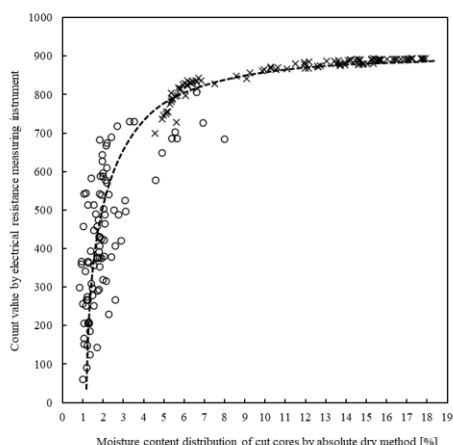
Figure 2-29 shows the relationship between the count value obtained by the insertion electrode and the moisture content obtained by the core-cutting absolute dry method. The count value and the moisture content obtained by the core cutting absolute dry method correspond well, and we decided to consider the approximate line in the figure as the calibration curve.

Figure 2-29. Relationship between count value by electrical resistance measuring instrument and moisture content distribution of cut cores by absolute dry method

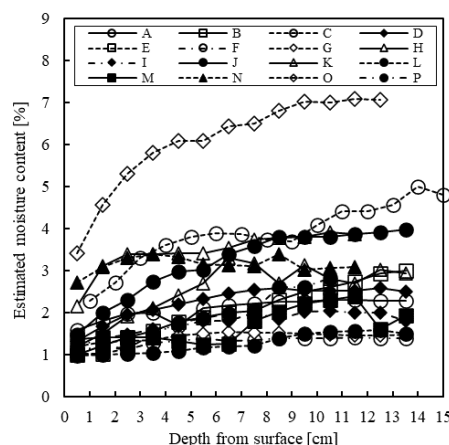
Estimated moisture content distribution of actual rammed earth structures in Bhutan. Figure 2-30 shows the estimated water content calculated from the electrode count values using the approximate line (calibration curve) in Figure 2-29. The moisture content is lower in the surface layer, and the change is moderate in the layer deeper than 4 cm.

Figure 2-30. Relationship between estimated moisture content and depth from surface

Except for ruined structures, it was found that the moisture content distribution generally decreased as the years passed after the construction of rammed earth. However, building A, which is believed to be over 100 years old, had a high moisture content.

In Building A, when we examined the difference between sunny and shaded areas, the moisture content distribution in sunny areas was clearly lower than that in shaded areas.

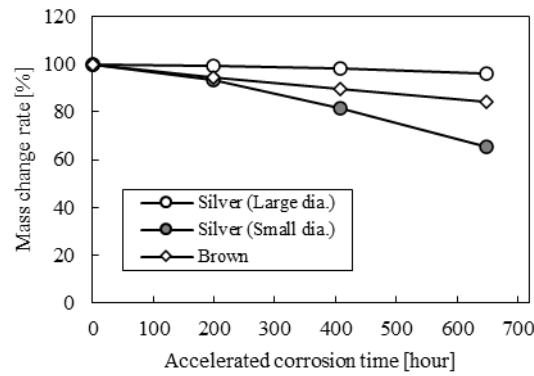
Figure 2-31 shows the relationship between acceleration time and mass change rate. The mass after 648 hours of acceleration was the smallest for silver (thin), which has the smallest diameter, at 66.5%, and the mass for brown, which has the largest diameter, was 84.2%, and silver (thick) was 96.1%.

Figure 2-31. Relationship between acceleration time and mass change rate

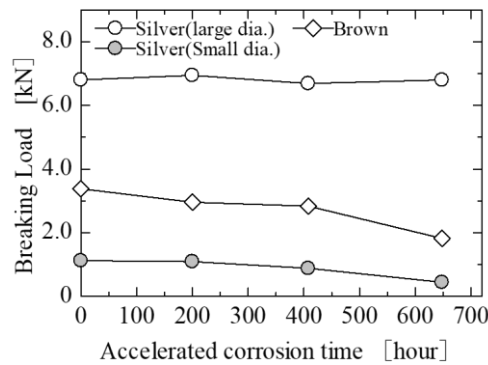
Figure 2-32 shows the relationship between acceleration time and tensile load capacity per wire. Silver (thick) was little change after 648 hours of acceleration. Silver (thin) and brown became smaller as the acceleration time passed. The change was greater in brown than in silver (thin).

Figure 2-32. Relationship between acceleration time and tensile load capacity per wire

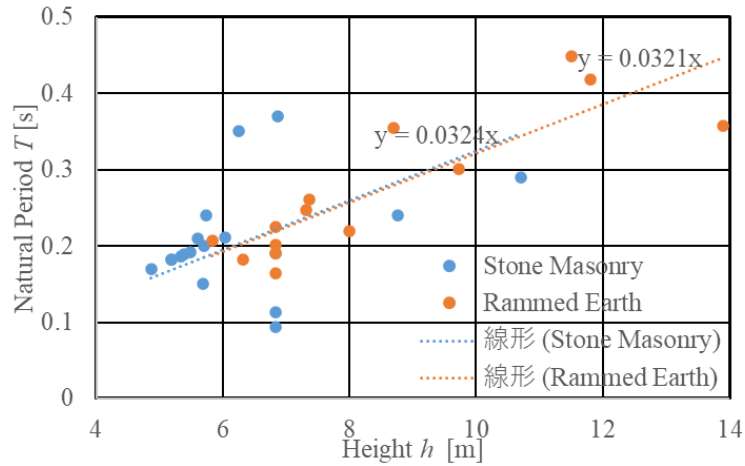
Figure 3-3 and Figure 3-4 show the relationship between the heights of Rammed Earth and Stone Masonry buildings where the microtremor measurements were conducted and the natural periods. The longitudinal direction and the short transversal direction are indicated separately in this figure. The natural periods are generally proportional to the heights of the buildings. From the statistical analysis of these data, Design fundamental natural period  $T$  will be derived, and then the vibration characteristic factor  $R_i$  will be calculated by taking into consideration with class of ground.

Figure 3-3. Relationship between natural periods and the heights of buildings

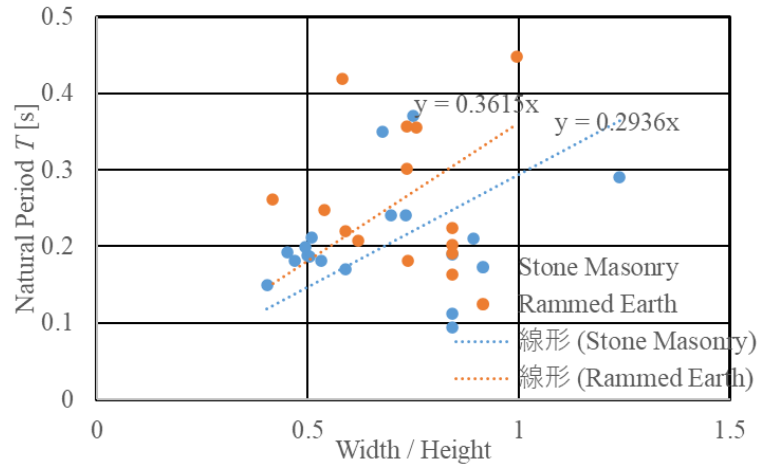
Figure 3-4. Relationship between natural periods and aspect ratio (Width/Height)

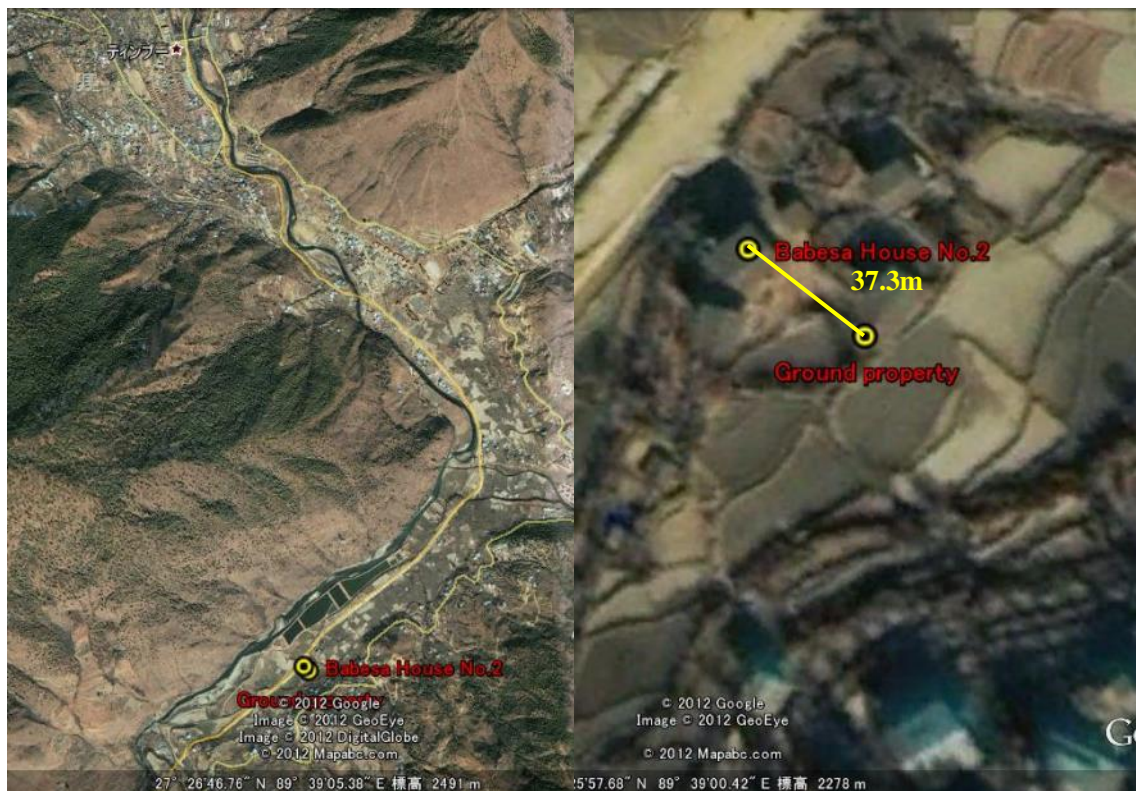
Figure 3-5. Location of microtremor measurement near the Babesa House No.2 (Google Earth Map)

Figure 3-5 and Figure 3-6 show the location of microtremor measurement about the ground. Figure 3-5 shows the ground 37.3m away from Babesa House No. 2 in the Thimphu suburb, and Figure 3-6 shows two nearby ground locations in the Tshenkher settlement of Talung village in the Haa Dzongkhag, where different earthquake damage occurred. In Figure 3-6, rammed earth buildings to the north, east, and south of the upper microtremor measurement location were damaged (indicated by red), while rammed earth structures to the north and south of the lower microtremor measurement location were not damaged (indicated by sky-blue). Instruments of microtremor measurement are shown in Figure 3-7 [1].

The H/V spectral method is a method of estimating natural frequency of the ground from the spectral ratio of horizontal motion to vertical motion. The H/V spectral ratios of the measurement points on the ground of Figure 3-5 and Figure 3-6 are shown in Figure 3-8. From Figure 3-8 (a), wherein the peak occurs at a relatively higher frequency, it was deduced that the nearby ground of Babesa House No. 2 is relatively hard. On contrary, as shown in Figure 3-8 (b), in the Tshenkher settlement of Talung village in the Haa Dzongkhag, the ground where the larger amount of damage occurred (red curve) peaked at a lower frequency compared to the area that suffered no damage (blue

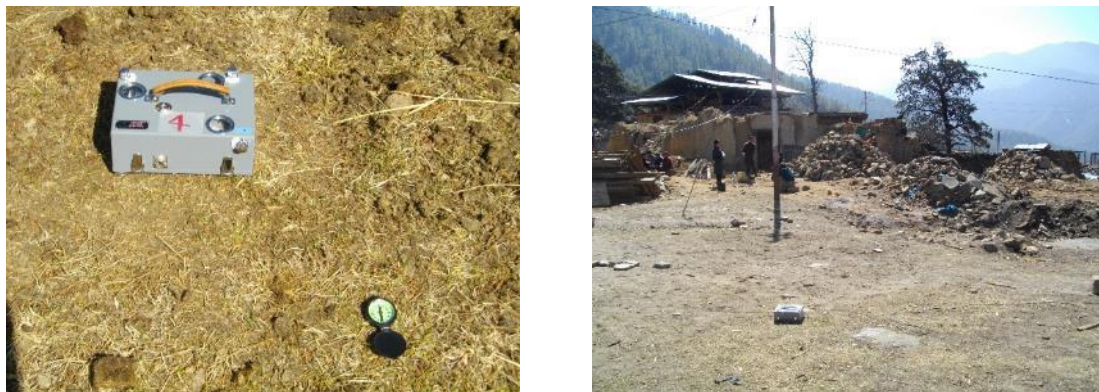
Figure 3-7. Microtremor measurement of ground at Tshenkher settlement of Talung village in the Haa Dzongkhag

curve); it had soft ground that would easily vibrate. In other words, from the H/V spectral ratio, it was estimated that in the Tshenkher settlement of Talung village in the Haa Dzongkhag, the ground where a larger amount of damage had occurred had soft ground that easily vibrated, as compared to the area that suffered no damage; and the nearby ground of Babesa House No. 2 is harder than the ground of the Tshenkher settlement in the Talung village.

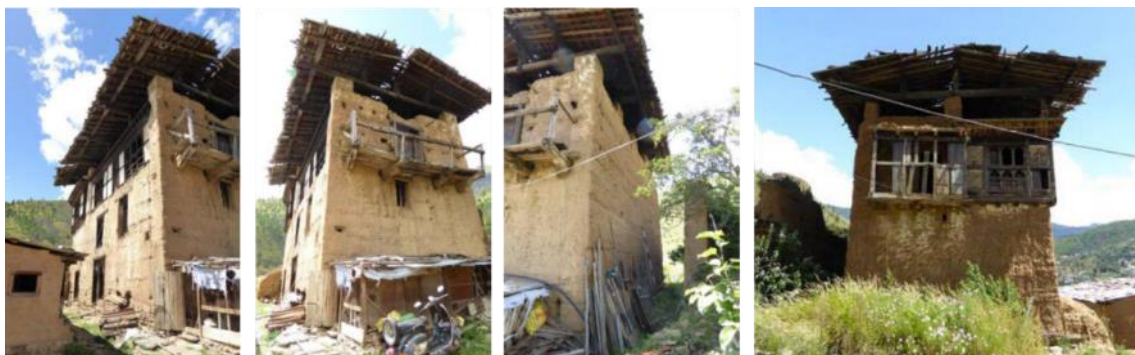
Figure 3-9. Monitoring of Rammed Earth building in Debsi, Thimphu

Monitoring is carried out on the Rammed earth building [5] and the stone masonry building.

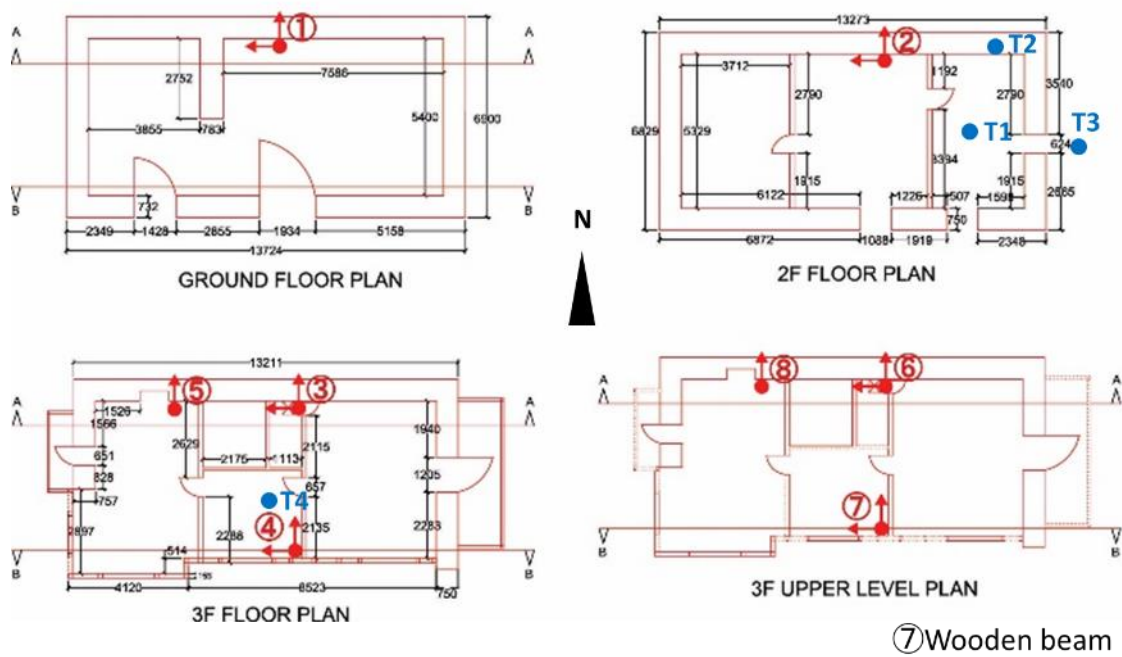
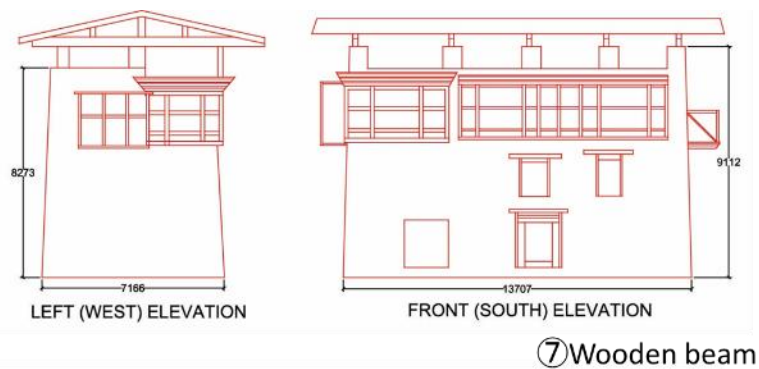
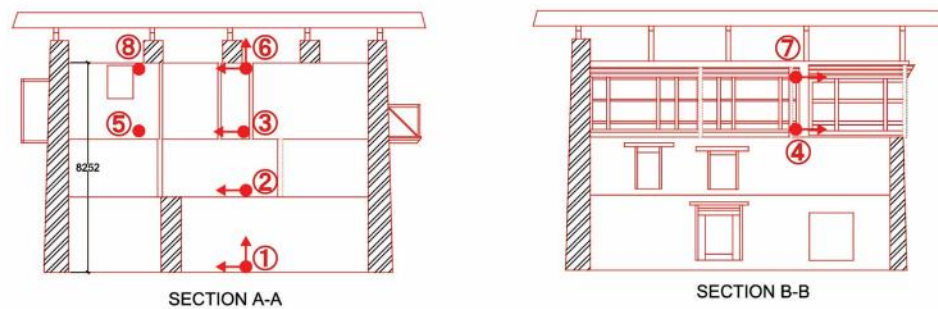
Accelerometer:  
 8 points  
 16 components  
 100 Hz  
 Thermocouple:  
 4 points  
 10 Hz

Figure 3-10. Measuring position and measuring condition

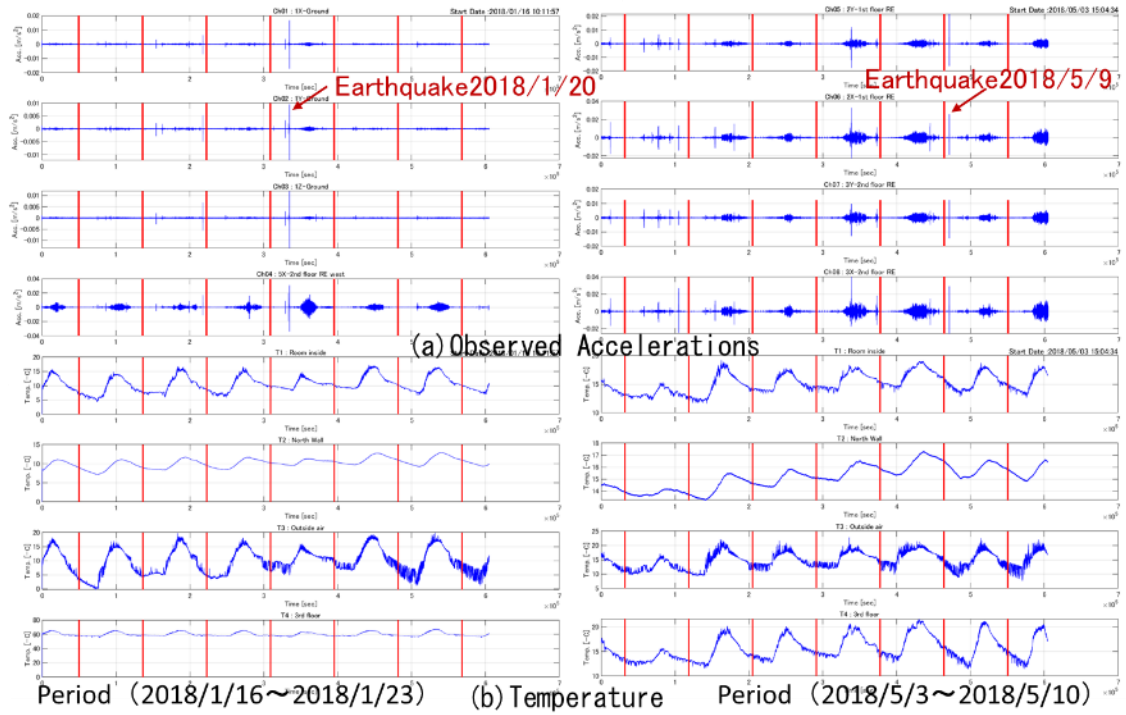
Figure 3-11. Observed Accelerations and Temperature

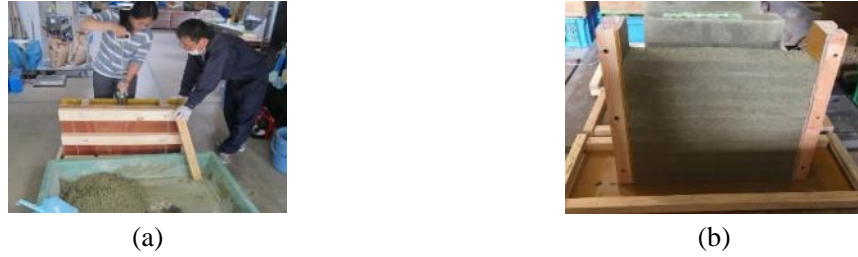
Figure 4-2: (a) Ramming to desired thickness; (b) Complete specimen

A total of 12 and 13 RE wallettes ( $500 \times 500 \times 110 \text{ mm}^3$ ) are tested in compression and shear, respectively. The considered parameters for both the test analysis are: i) Drying period (3 and 12 months) and ii) Layer thickness (50 mm and 100 mm). The soil used for the present study is reconstituted with a soil-sand ratio of 1:0.5 by volume [6]. The grain size distribution of the soil sample used has a particle size ranging from 0 to 10 mm. The specimen preparation involved manual compaction of moistened soil inside the formwork (Figure 4-2). The upper part of the layer achieved better compaction than the lower one. Further, 50 mm layer wallet achieved better compaction while honeycombs were found at the lowest level of the layer in case of 100 mm wallet, as seen in Figure 4-3. The formwork was removed immediately after completion of full specimen, allowing it to dry.

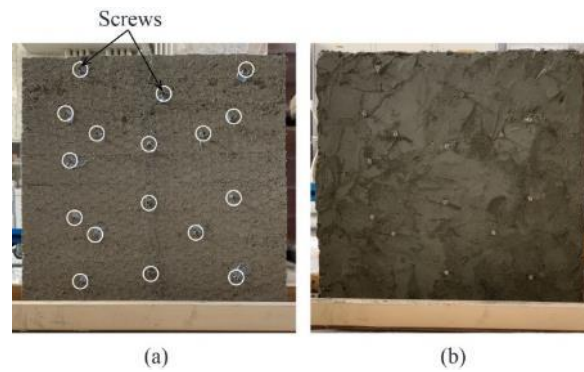
Figure 4-4. Strengthening details: (a) Fixation of mesh and screws; (b) Final view after plastering specimen

The proposed mesh-wrap strengthening method is effective in strengthening the RE wallettes tested under all considered parameters, as shown in Figure 4-9. The shear screws in Figure 4-4 were observed effective in controlling the mesh's delamination throughout the loading, and the delamination of mesh was observed only at the final failure.

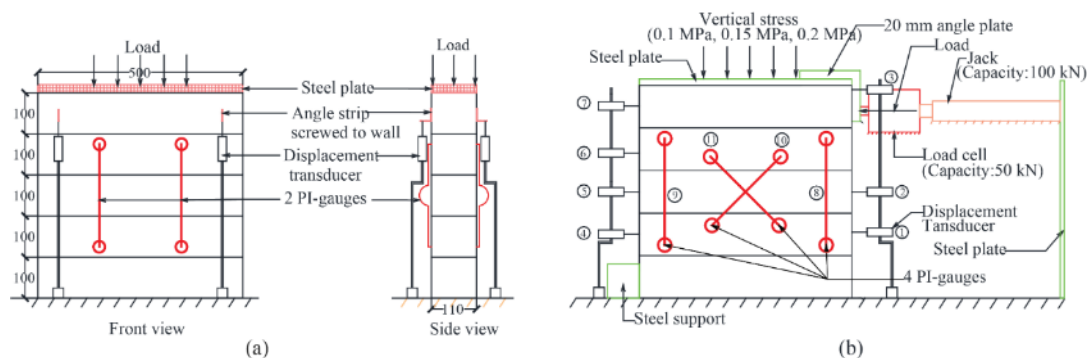
The experimental setup for a compression test and a shear test is shown in Figure 4-5. For the compression test, two transducers and two PI-gauges were fixed at both faces of the wallet to measure the vertical displacement. A vertical load was applied through Universal testing Machine (UTM) until the failure of the wallet. For the shear test, seven transducers were fixed at different layers of RE wallet to record the horizontal displacement during the loading while two PI-gauges having a gauge length of 250 mm was placed diagonally to keep track of the cracks. Additional two PI-gauges were also fixed to record the vertical displacement. A slow and consistent horizontal load was applied until the failure through load cell (capacity 500 kN) with jack having a stroke of 150 mm while vertical stress is applied with UTM. The different normal stresses applied for each specimen were 0.2 MPa, 0.15 MPa and 0.1 MPa representing the first storey, the second storey and the roof respectively.

Figure 4-5. Test set up: (a) Compression test; (b) Shear test

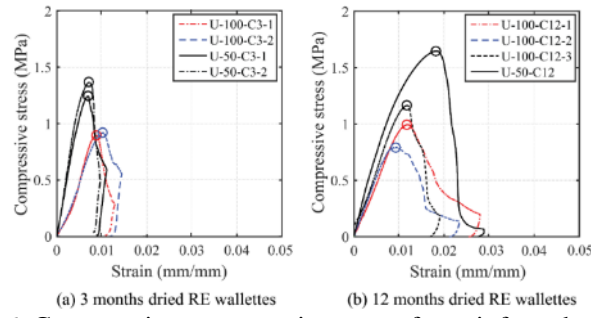
Figure 4-6 shows the relationship between the compressive stress and strain for all RE wallettes tested under compression loading. Figure 4-7 shows the relationship between the shear load and displacement for all specimens tested under shear loading. It is observed that there is a steady increase in both compressive and shear strength as the drying period increases for both 100 mm and 50 mm layer wallettes. Furthermore, under both loading conditions, the strength for RE wallet with thinner layer 50 mm achieved better strength than the wallet with a thicker layer 100 mm. The higher strength in 50 mm layer wallet can be attributed to better compaction achieved comparing to the 100 mm layer wallet. The honeycombs in 100 mm layered wallet, seen in Figure 4-3, reduced the interface layer strength and thereby, affected the overall strength. From Figure 8, a gradual increase in shear strength is observed with an increase in vertical stress for all the RE wallettes with different layer thickness and drying periods.

Figure 4-6. Compressive stress-strain curve of unreinforced wallettes

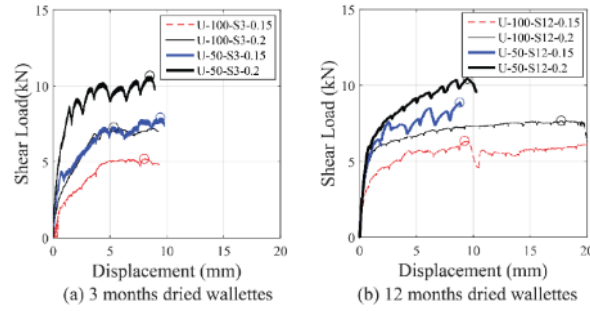
Figure 4-7. Shear load-displacement curve of unreinforced wallettes

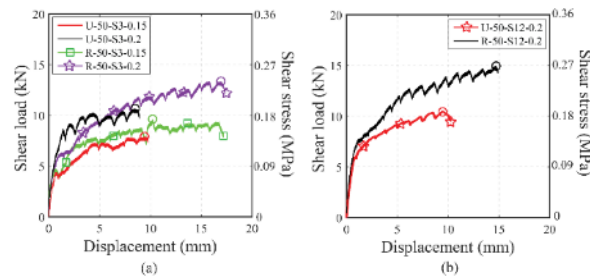
Figure 4-9. Shear load-displacement curve of strengthened wallettes: (a) 3-months dried; (b) 12-months dried

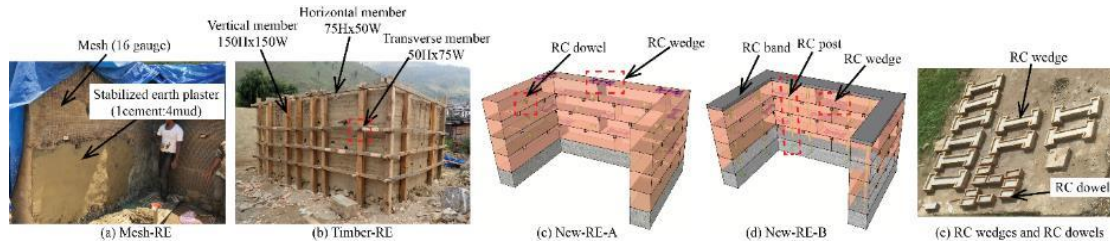
Figure 4-15. Specimen showing strengthening details: (a) Mesh-RE; (b) Timber-RE; (c) New-RE-A; (d) New-RE-B; (e) RC wedges and RC dowels inside formwork

The test program involved the preparation of five full-scale U-shaped specimens, namely unreinforced RE (U-RE), mesh-wrapped retrofitted RE (Mesh-RE), timber-framed retrofitted RE (Timber-RE), reinforced RE with reinforced concrete (RC) dowels and wedges (New-RE-A), and reinforced RE with RC posts, wedges, and band (New-RE-B). The specimen had a dimension of 5.4 m  $\times$  3.3 m  $\times$  2.4 m with a wall thickness of 0.6 m. The specimens Mesh-RE and Timber-RE aim to strengthen the existing structure, while specimens New-RE-A and New-RE-B aim to strengthen the new construction. The details of each specimen are presented in Figure 4-15. It should be noted that the details of specimen U-RE are not presented here for brevity and are similar to the rest of the specimens without the strengthening measures.

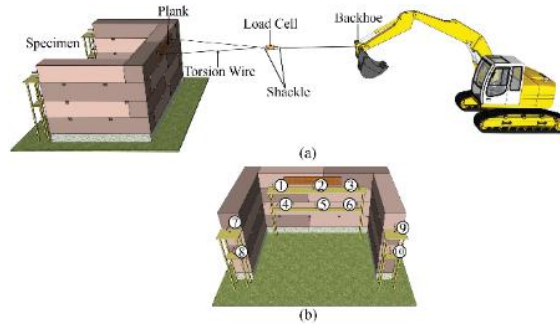
Figure 4-16. Test setup: (a) Overall view of pull-down test; (b) Location of transducers

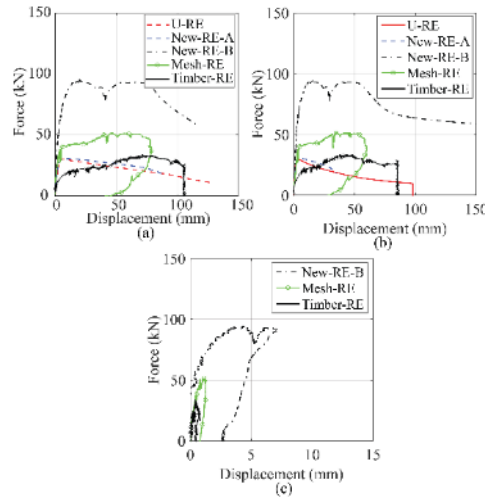
Figure 4-17. Load–displacement relationship at: (a) Top facade; (b) Mid facade; (c) Top of transverse wall

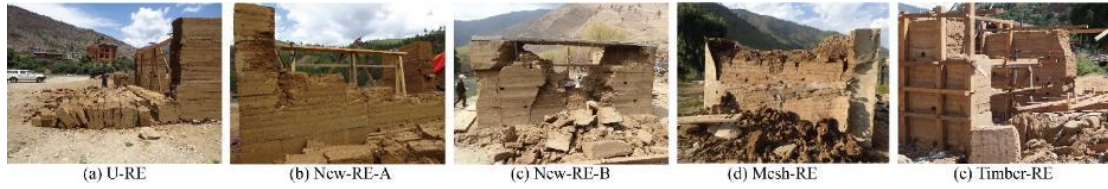
Figure 4-18. Final failure modes of all RE walls under out-of-plane loading

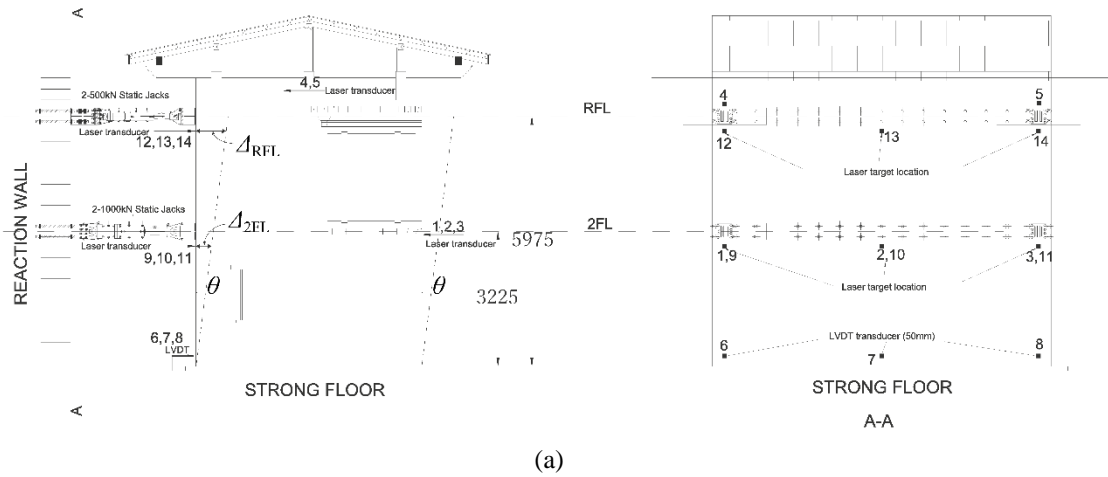
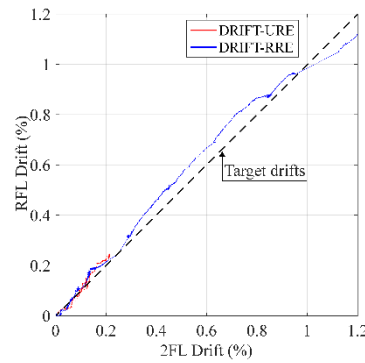
Figure 5-4: (a) Test set-up and instrumentation; (b) Actual and target storey drifts

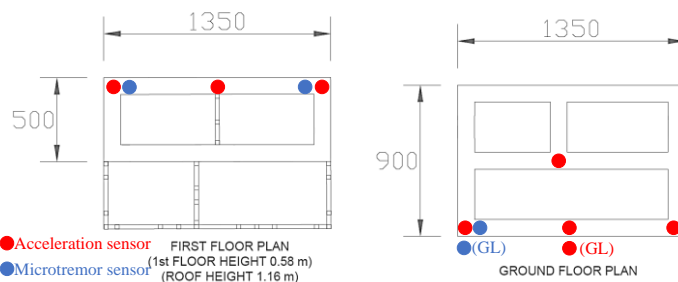
Figure 6-1. Plan of specimen

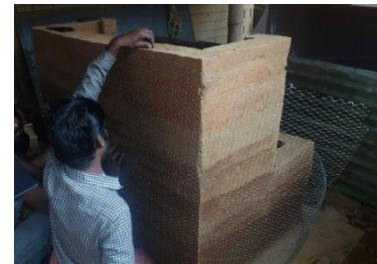
Figure 6-2. Reinforcement with wire mesh

The specimens were geometrically reduced to a scale of 1:6. As shown in Figure 6-1, the two-storied prototype building had a floor area of 1350 mm × 900 mm, with a height of 580 mm for each floor. The wall thickness was 100 mm. After completing the construction, two of each specimen types were retrofitted with a mesh wrapping technique same as in the previous studies [15,16]. As shown in Figure 6-2, a hexagonal shaped chicken wire mesh having 0.4 mm diameter was used as the main material for retrofitting and anchored using nails. 10 mm thick cement plasters with a 1:3 cement–sand ratio were used to provide better bonding between the walls, mesh, and plasters.

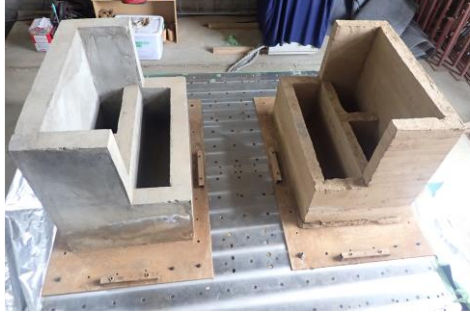
Figure 6-4. Installation of specimen

The shaking table tests were performed on two specimens at the same time: one was unreinforced, and the other was retrofitted. Comparisons were made on the spot, as shown in Figure 6-3. The response of the structure was measured using an accelerometer (STP-300S), and data logging was conducted using the National Instrument System (Signal Express). A total of 16 accelerometers were used to measure the response of the two specimens: eight on the unreinforced specimen and eight on the retrofitted specimen. For each specimen, one sensor was installed at the base, four at the second-floor level, and three at the roof level, as shown in Figure 6-1. The sampling frequency was set to 200 Hz.

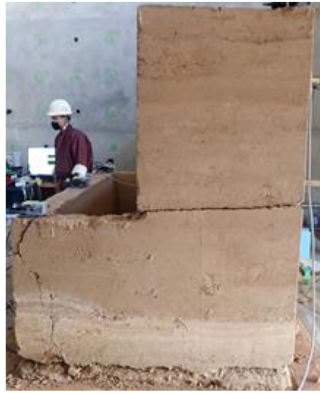
(a) URE

The test results for the short direction are as follows: After a nominal PGA of 0.8 g for an unreinforced rammed earth specimen (URE), the acceleration factor became almost the constant between the floor and roof level, and the natural frequency drastically dropped because of the occurrence of large horizontal cracks at the floor level and huge vertical cracks in the middle of the back wall (Figure 6-7 (a)). In a retrofitted rammed earth specimen (RRE), the acceleration factors gradually decreased at both the floor and roof levels and approached 1.0, owing to the effect of rocking. However, the natural frequency was almost constant, and there were few cracks although the nominal PGA increased in steps (Figure 6-7 (b)). In an unreinforced stone masonry specimen (USM), the acceleration factor was close to 1.0, at the roof level from the beginning owing to initial cracks, and the natural frequency was almost constant despite the gradual increase in the number of cracks. After a nominal PGA of 0.8 g, the natural frequency drastically decreased because of the occurrence of large horizontal cracks on both sides at the floor level (Figure 6-7 (c)). In a retrofitted stone masonry

Figure 6-7. Crack patterns after tests (Short direction)

The acceleration response factors at the floor and roof levels, crack patterns after tests in the short and long directions, and changes in natural frequencies are shown in Figure 6-6–Figure 6-9, respectively. The acceleration response factors were obtained from the average absolute peak acceleration response at each level by the absolute peak acceleration at the shaking table level. The measured values were used for the analysis after baseline correction and filtering using the band-pass filtering technique with cut-off frequencies of 1–50 Hz. Microtremor measurements of the specimens were performed before and after each test to understand the change in the vibration characteristics. The data loggers and sensors used for the measurement were GEODAS 15HRS and CR 4.5-2S velocity sensors, respectively. Microtremor waves were measured over 3 min by setting four sensors at each level in both directions, as shown in Figure 1, at a sampling frequency of 200 Hz. Subsequently, the measured values were divided by 20.48 s after filtering using the band-pass filtering technique with cut-off frequencies of 1–50 Hz. Those portions with less noise, such as those caused by traffic vibrations, were subjected to ensemble averaging and smoothing (Hanning Window:30). The obtained records were Fourier-transformed and the natural frequency of the specimen was estimated from the ratio of the Fourier spectra at each measurement point to that at the roof level.

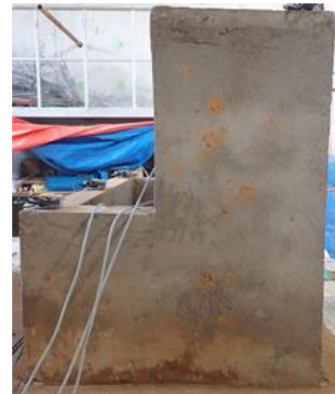
(d) RSM

specimen (RSM), the acceleration factors at the roof level and the natural frequency gradually decreased, although almost no cracks appeared on the surface of the exterior walls. (Figure 6-7 (d))
